# Wyoming Veteran's Memorial Museum

## 1942 Chevrolet Fire Truck Project Update

### Week Ending 4/11/2020

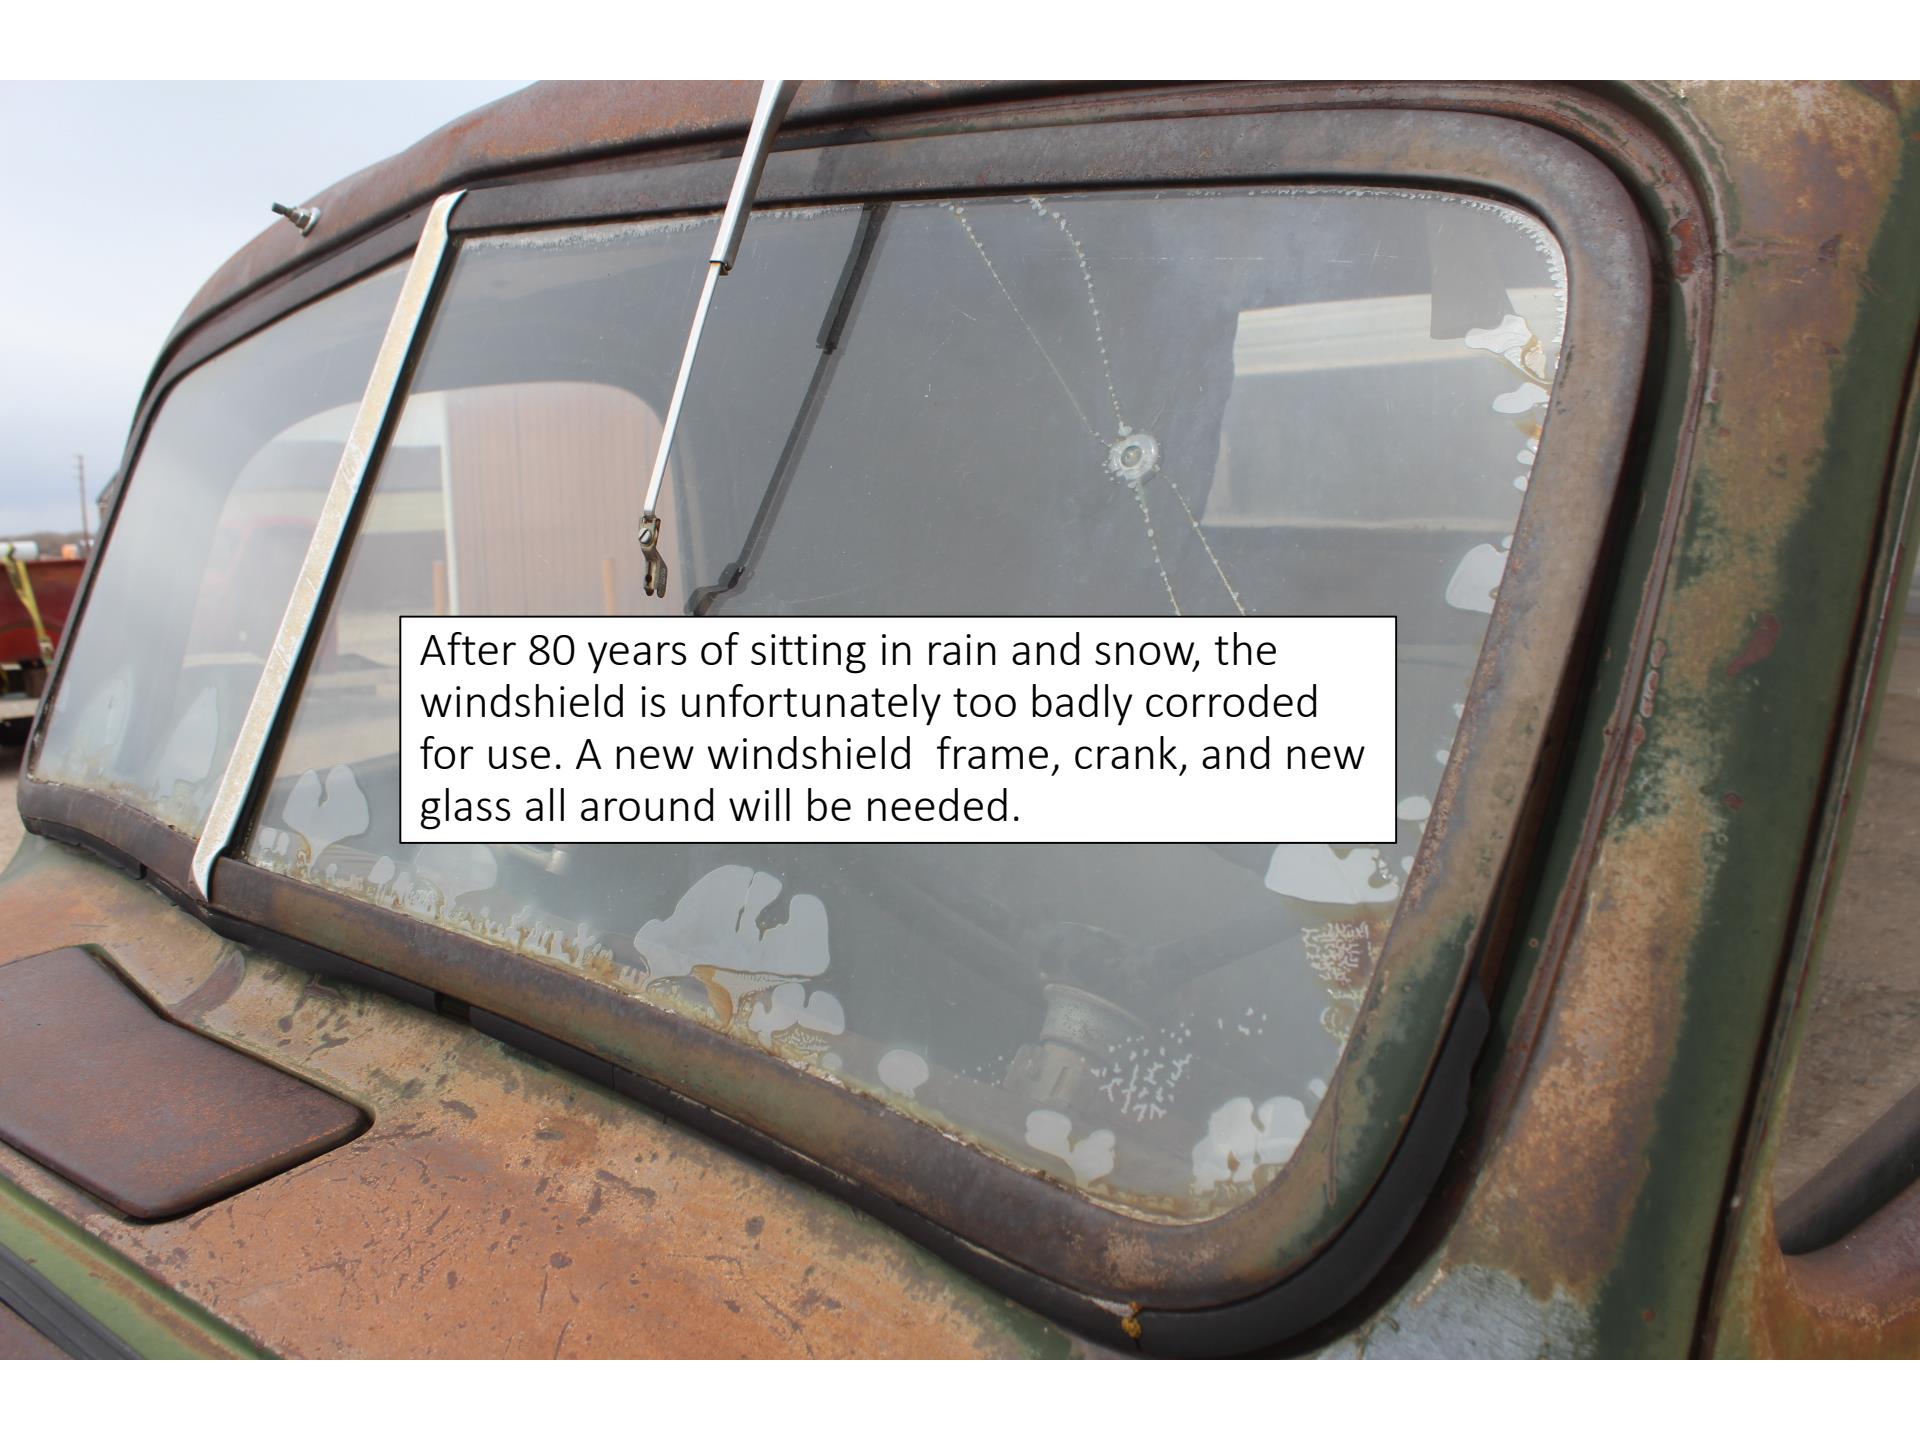
After 80 years of sitting in rain and snow, the windshield is unfortunately too badly corroded for use. A new windshield frame, crank, and new glass all around will be needed.

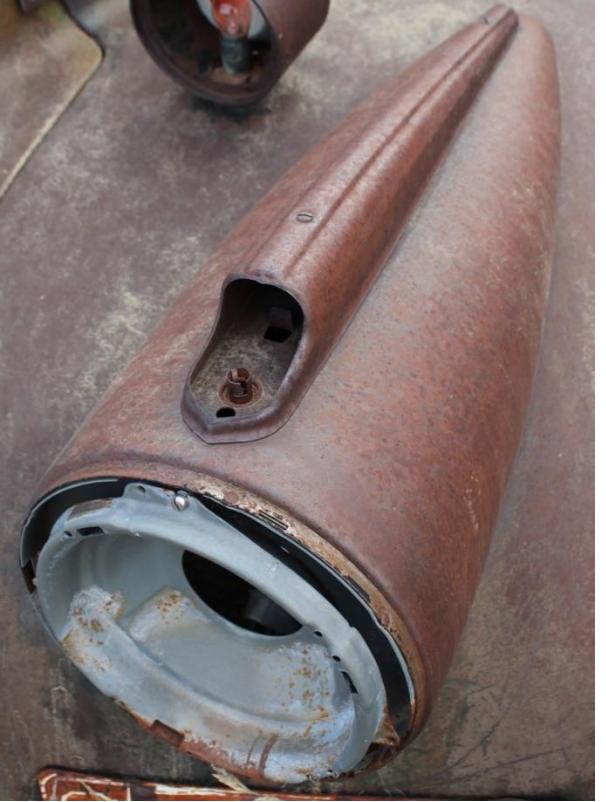
The 1941 drivers door will be used on the fire truck. The mirror will be changed to the Army type used during WWII (mounted on the door hinge). The LH headlight assembly will also be salvaged for the fire truck.

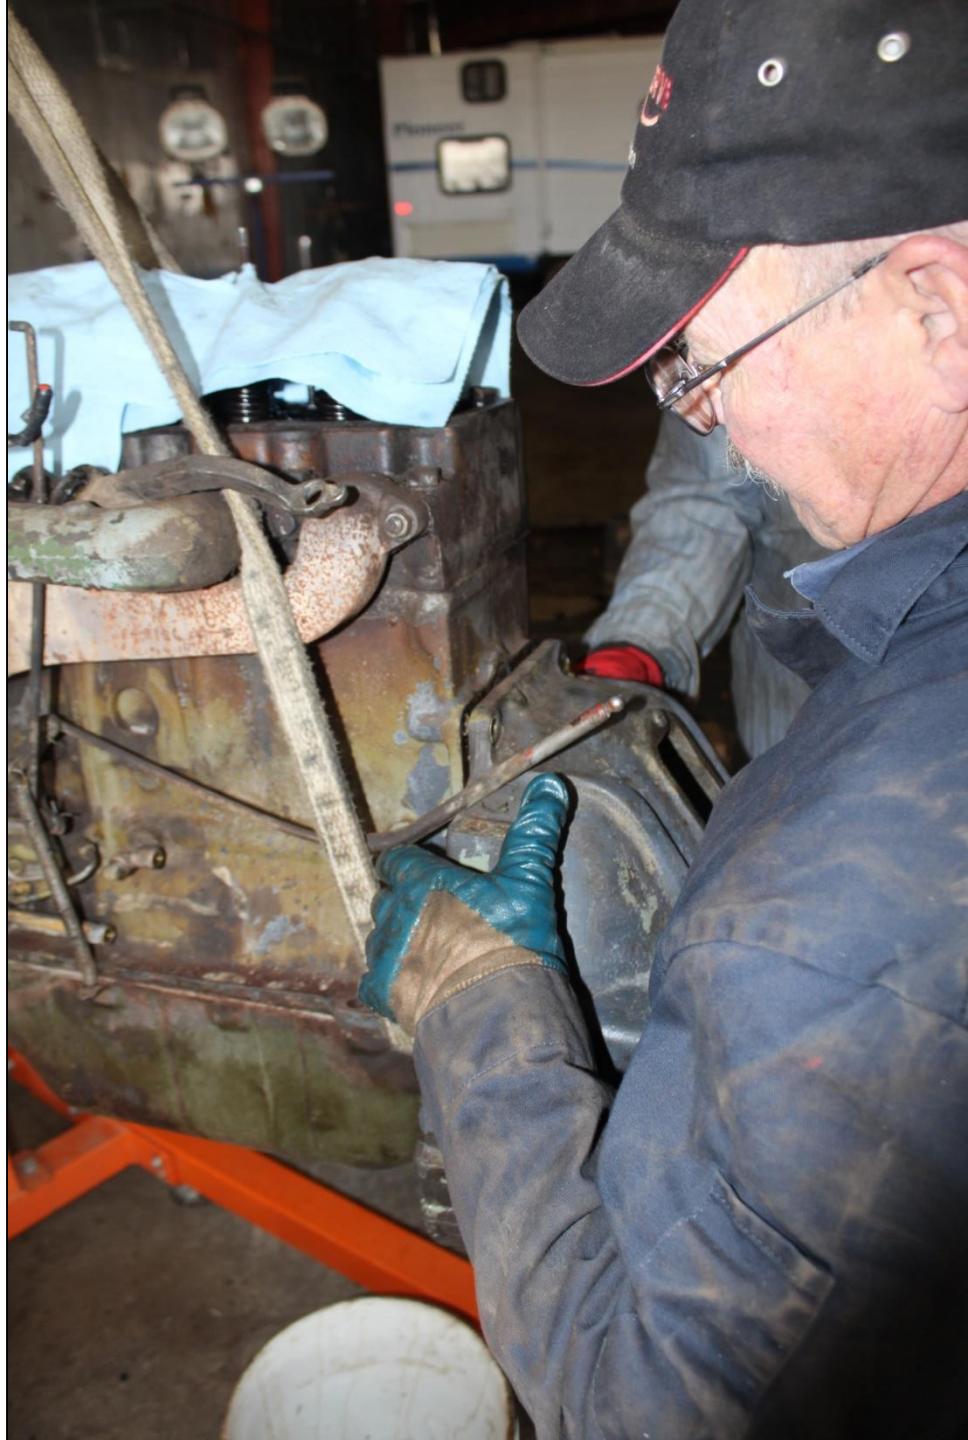
Mike Johnson and Mike Kennedy remove the bellhousing from the engine block. The clutch and flywheel had to be removed to get at the bellhousing bolts. The clutch components have had reasonably good care, and will not be replaced. The throwout bearing is an inexpensive maintenance item, and will be replaced.
