**Wyoming Veteran's Memorial Museum
1942 Chevrolet Fire Truck Project Update
Week Ending 5/30/2020
For public release.**

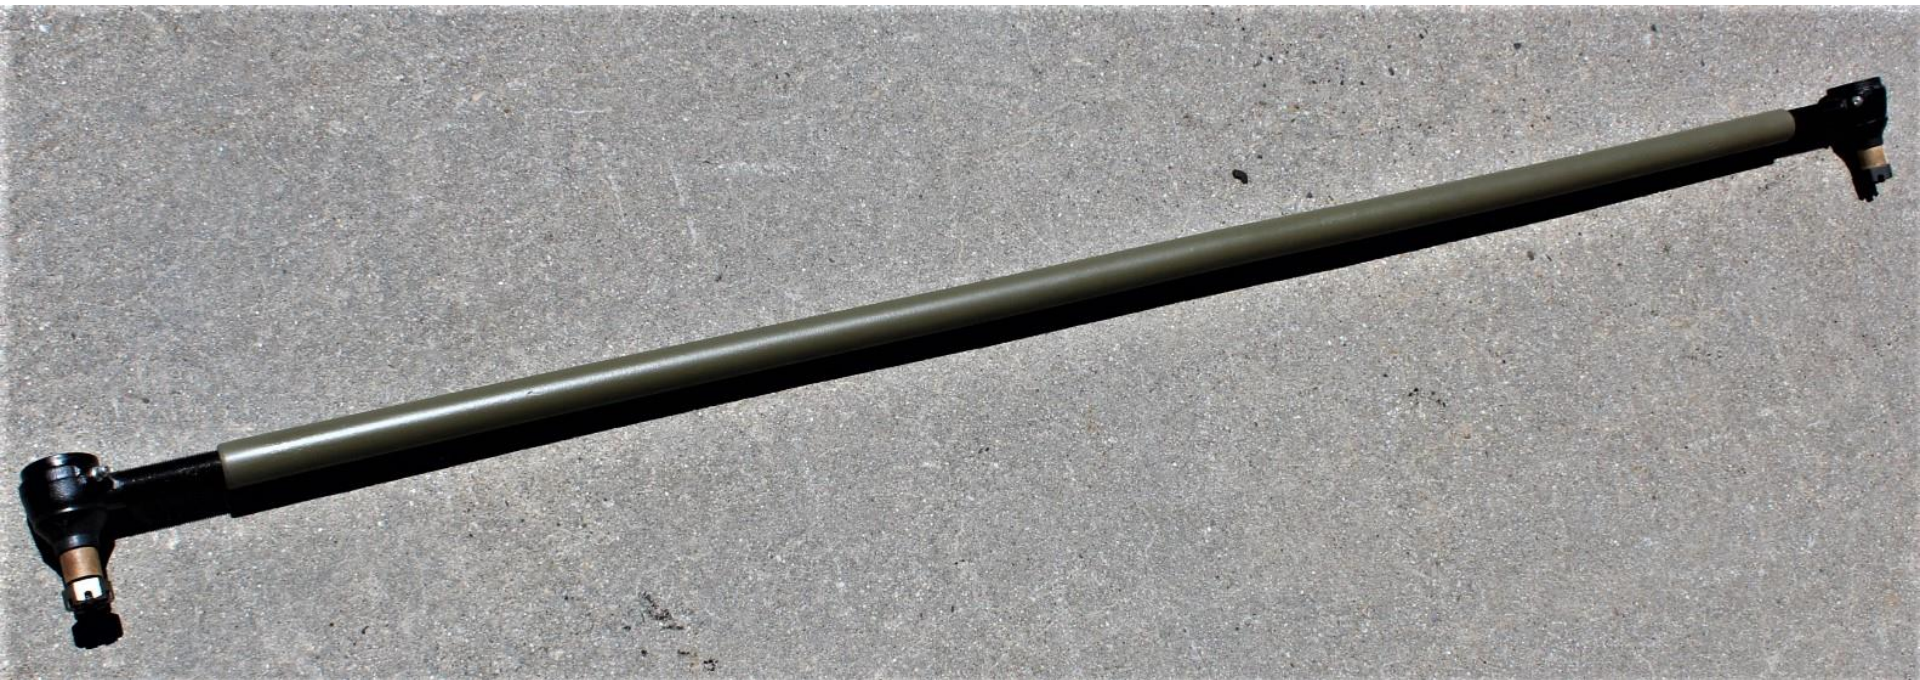
Straightened and restored tie rod is ready for installation with new tie rod ends.

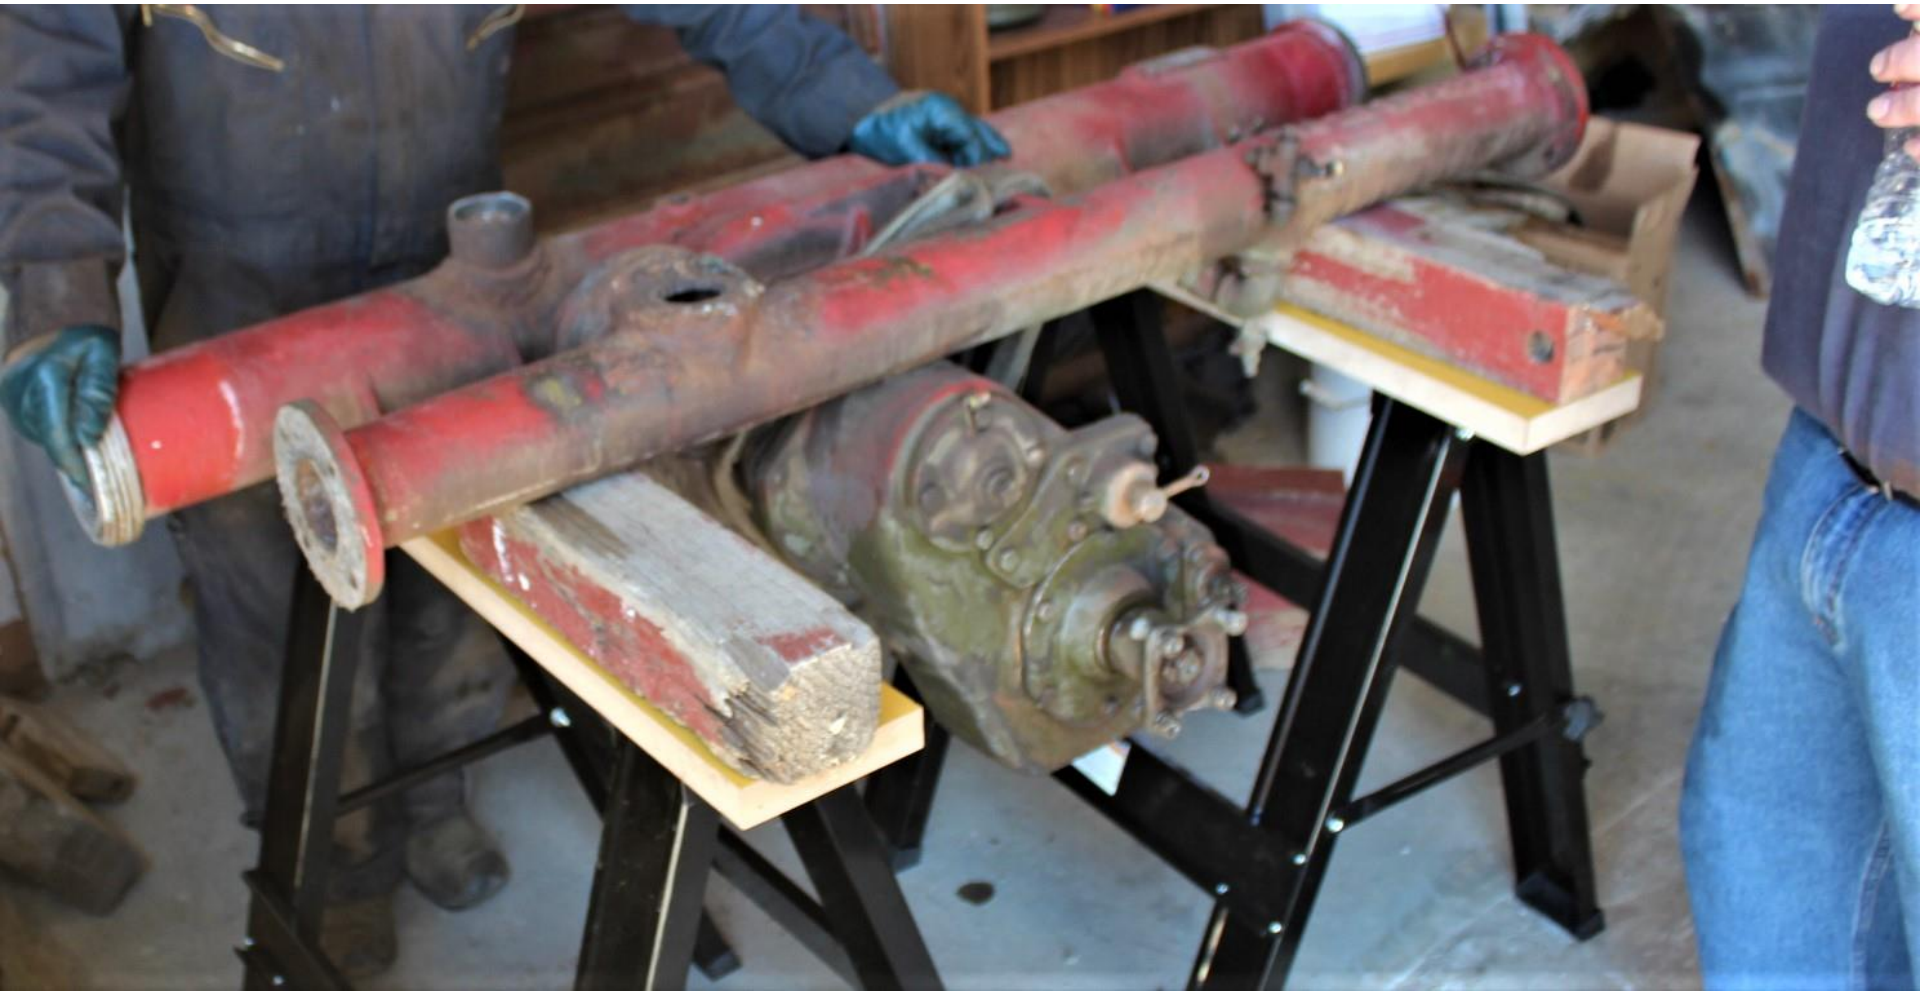
Saw horse stands were built by Jerry Russell and John Grudgeon. Fortunately, Jerry understands Chinese and could read the instructions. The fire pump was placed on the stands and made ready for cleaning and detailing. Although the pump will not be used, the transfer case will require new seals.

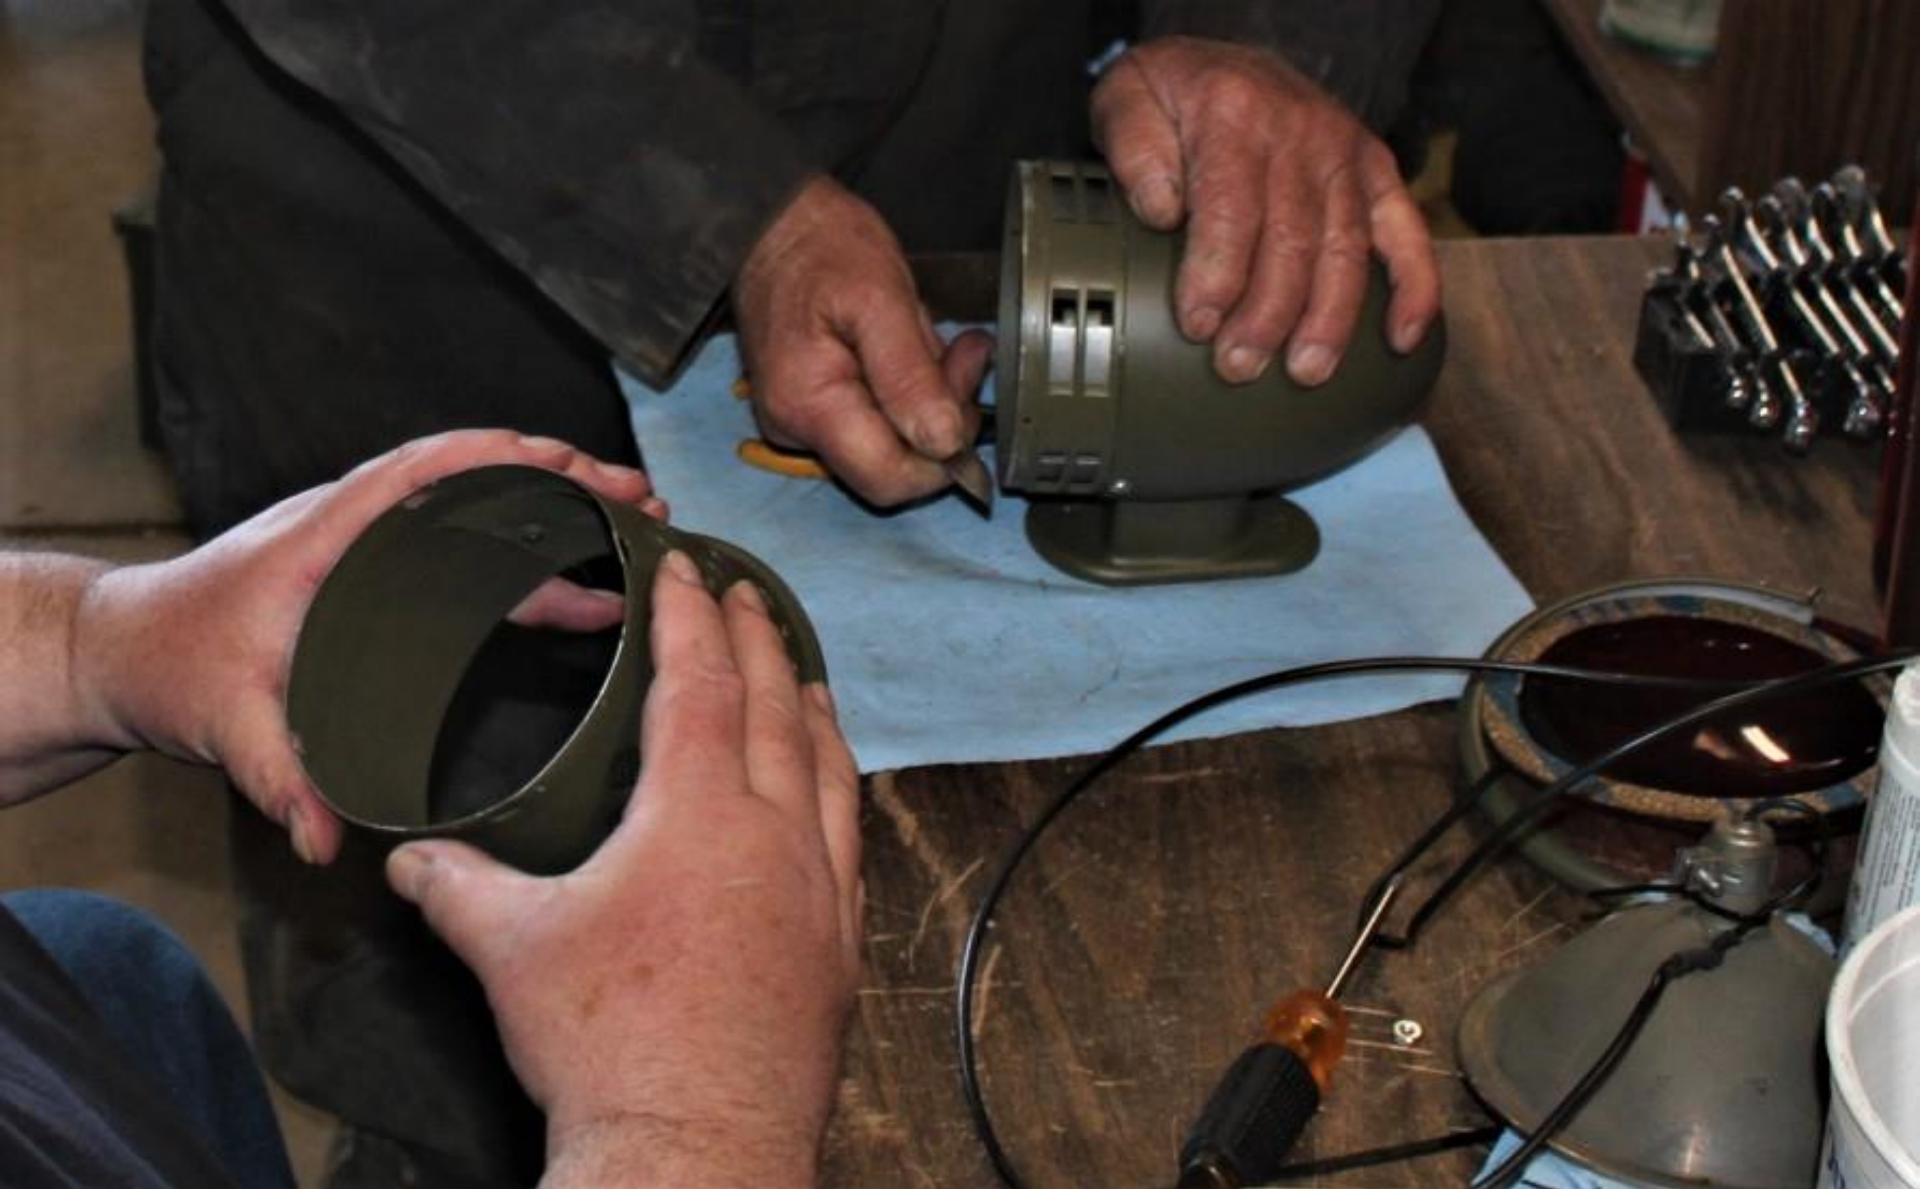
Siren and light modules are being assembled by Mike Johnson and John Grudgeon. The electrical components were restored earlier. Doug Walters painted the cases. The siren is as loud now as when it was new.

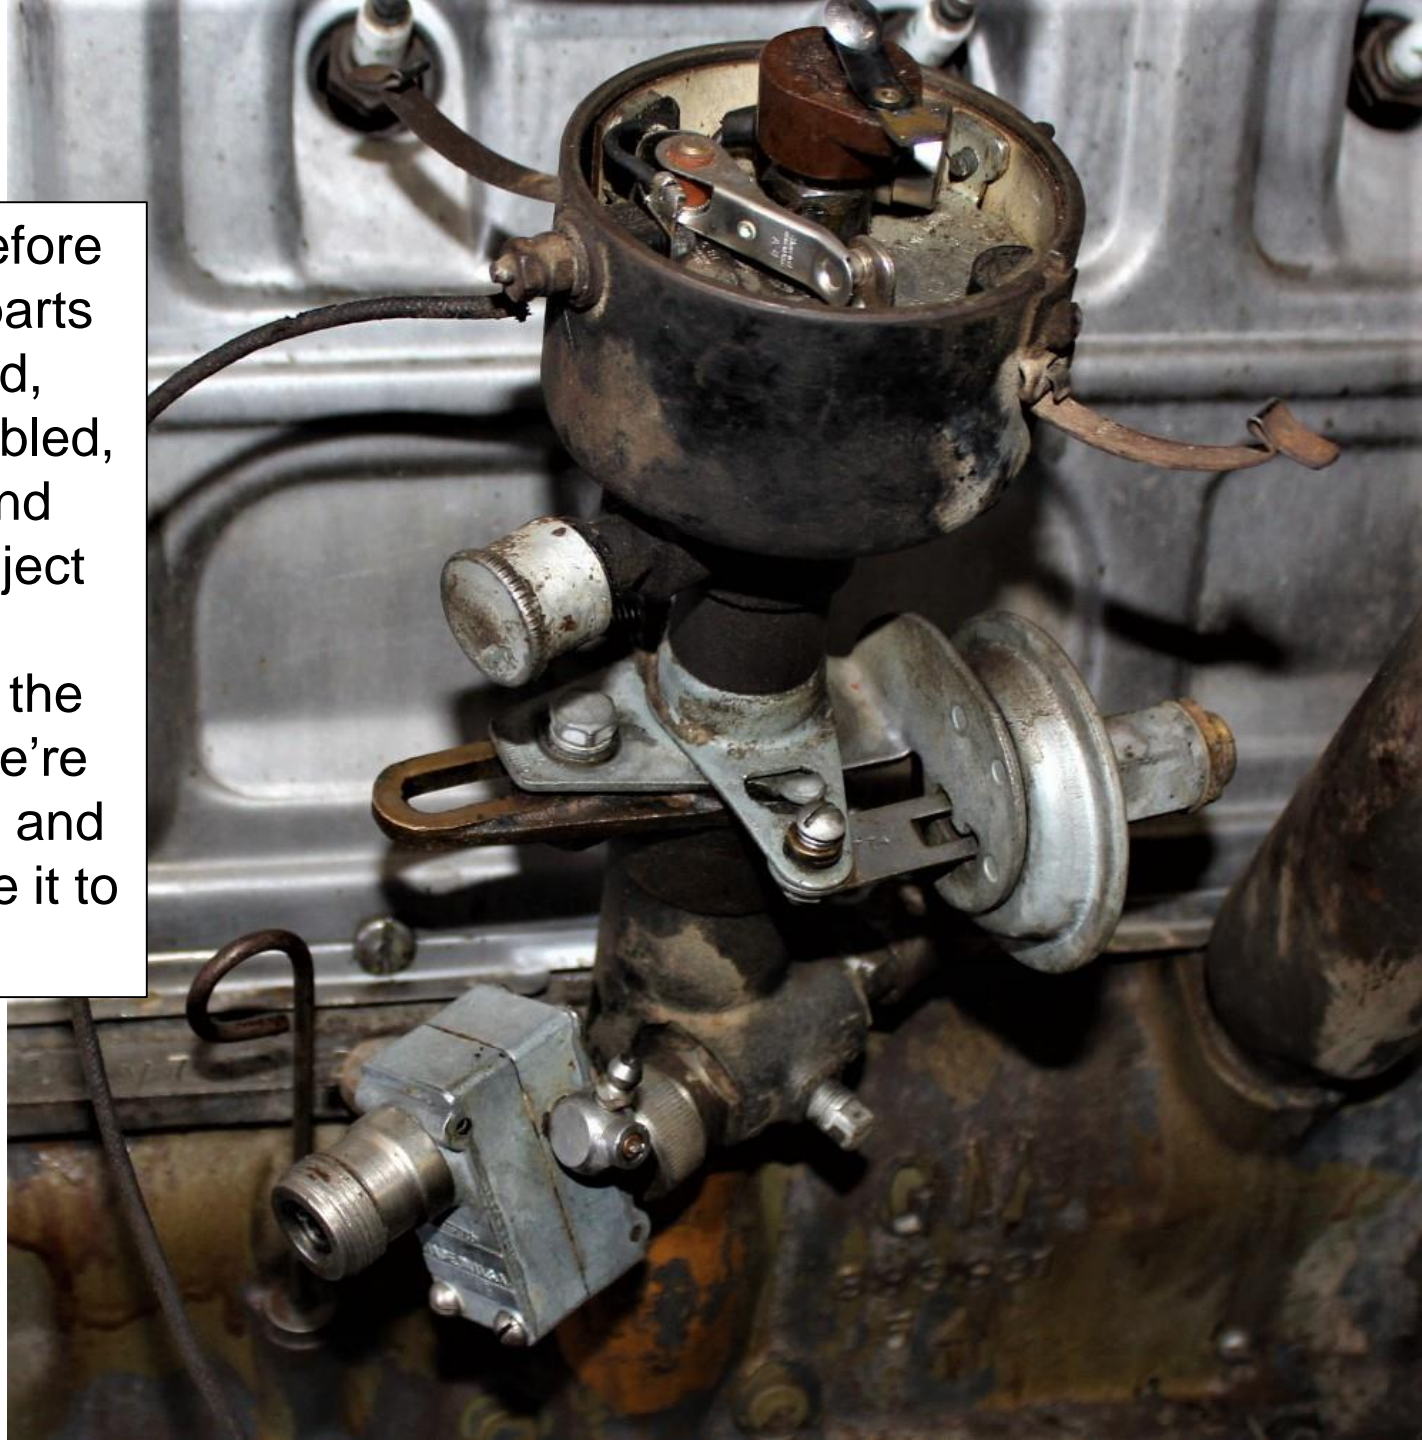
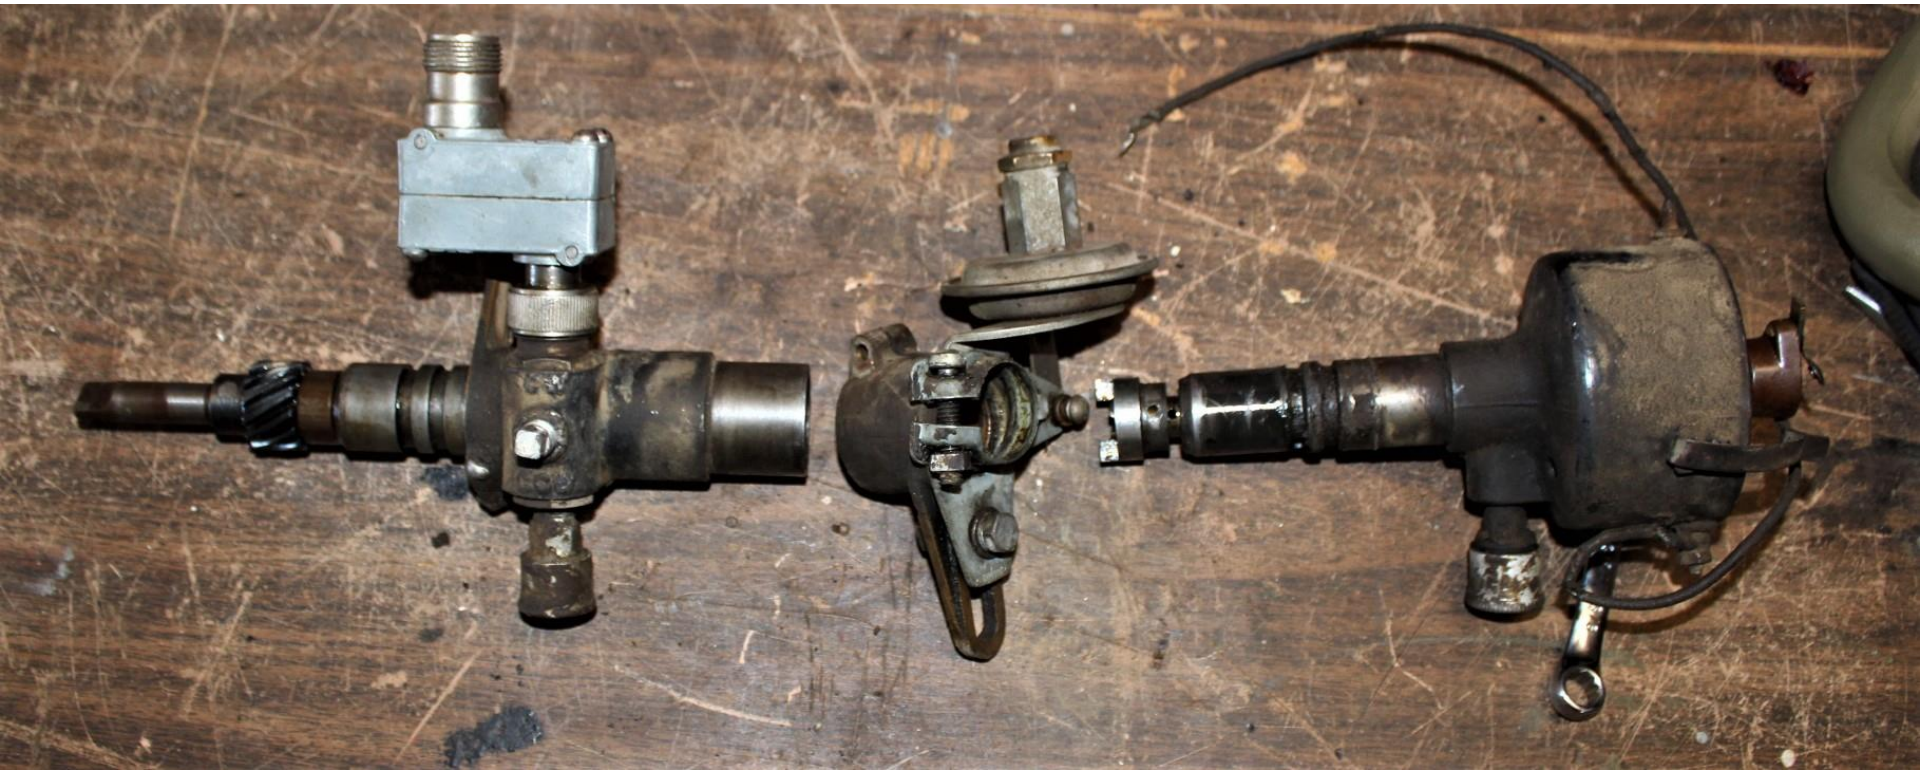
The engine distributor modules are disassembled. Further disassembly and detailing will be done. New point and condenser will be installed.

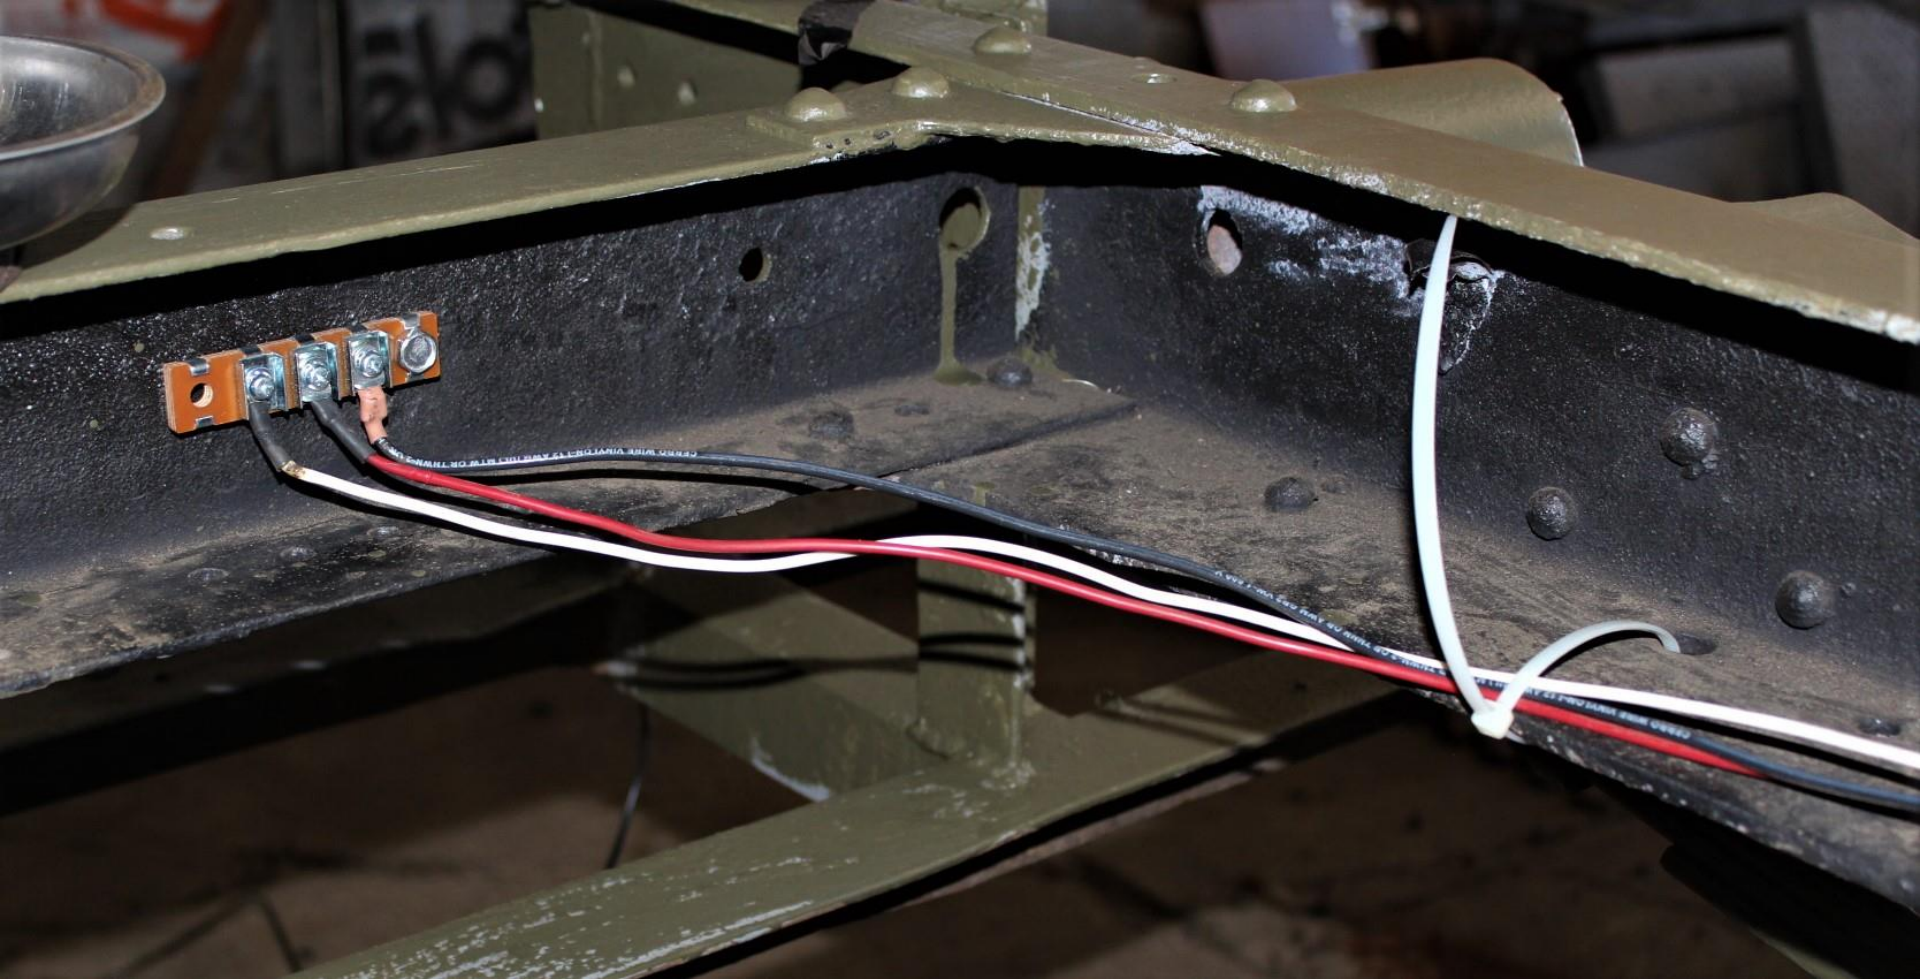
Fire truck flood light and blackout wiring has begun. Here, the white wire is for the blackout marker light. The red wire is for the blackout brake light. The black wire will feed the two flood lights on the rear of the box. Tie-wrap is only temporary. Proper cable clamps will be installed after the OEM harness arrives. The terminal strip is a reproduction of a genuine GM part of that period.
