# Wyoming Veteran's Memorial Museum

## 1942 Chevrolet Fire Truck Project Update

### Week Ending 4/11/2020

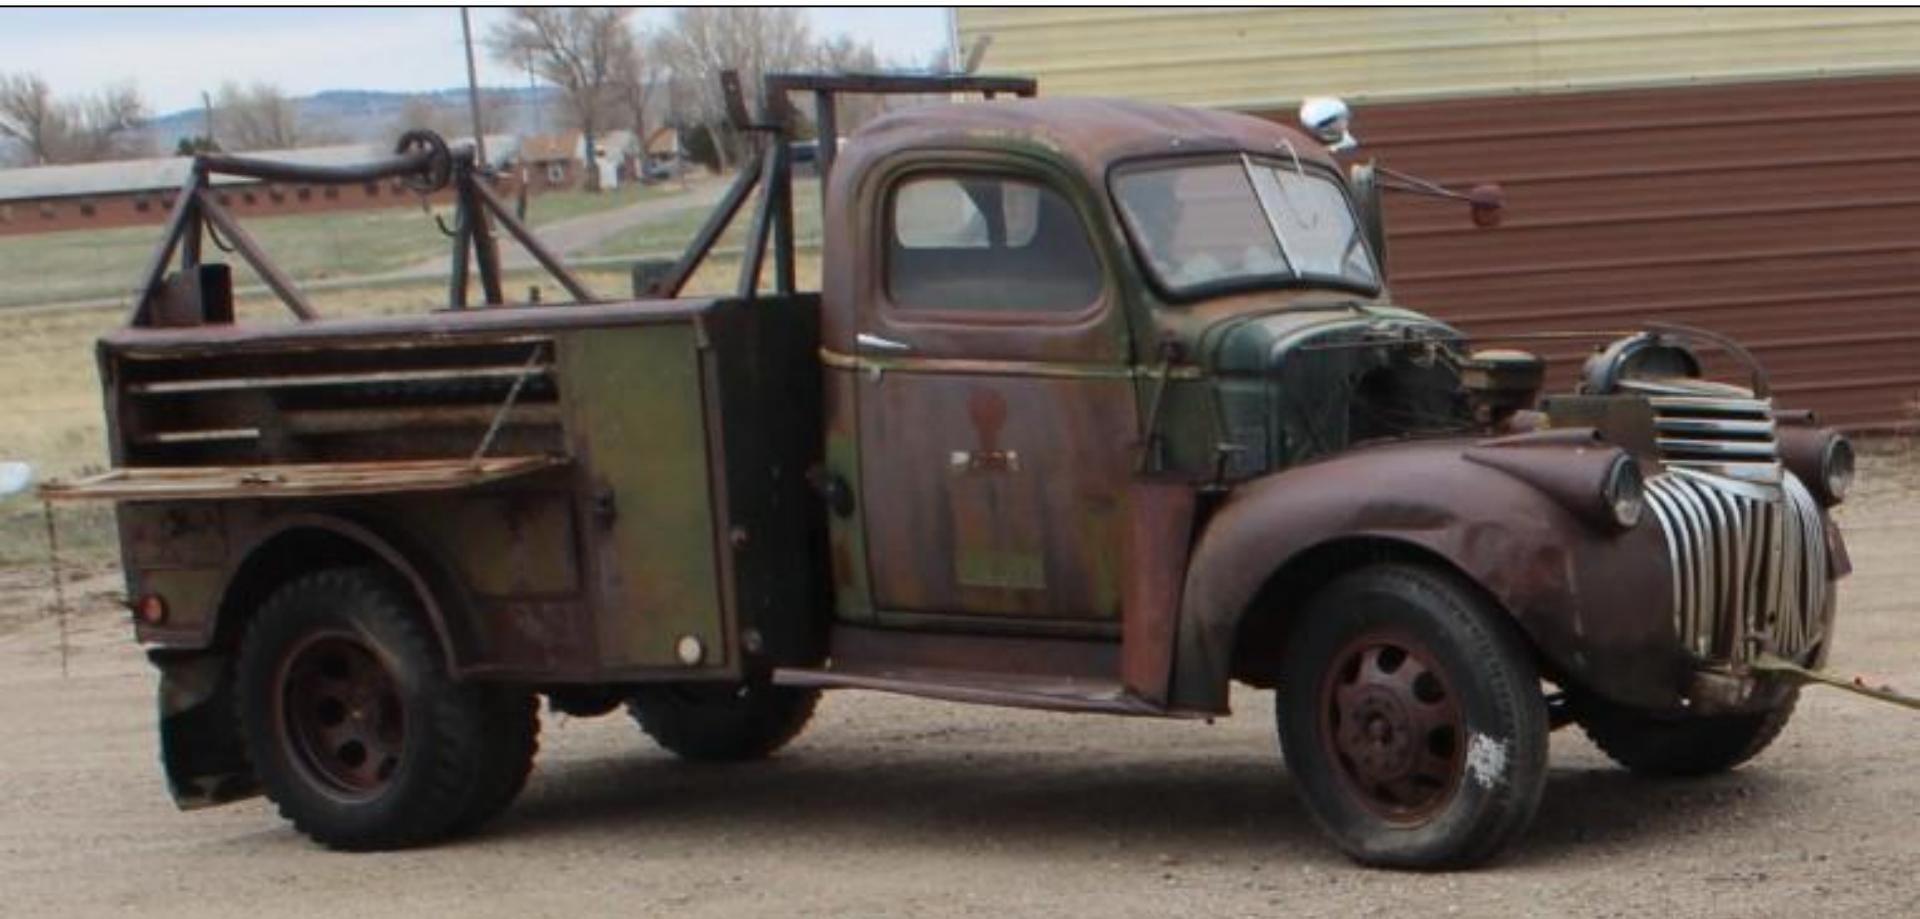
Mike Kennedy tows the 1941 Chev into the shop while Mike Johnson steers.

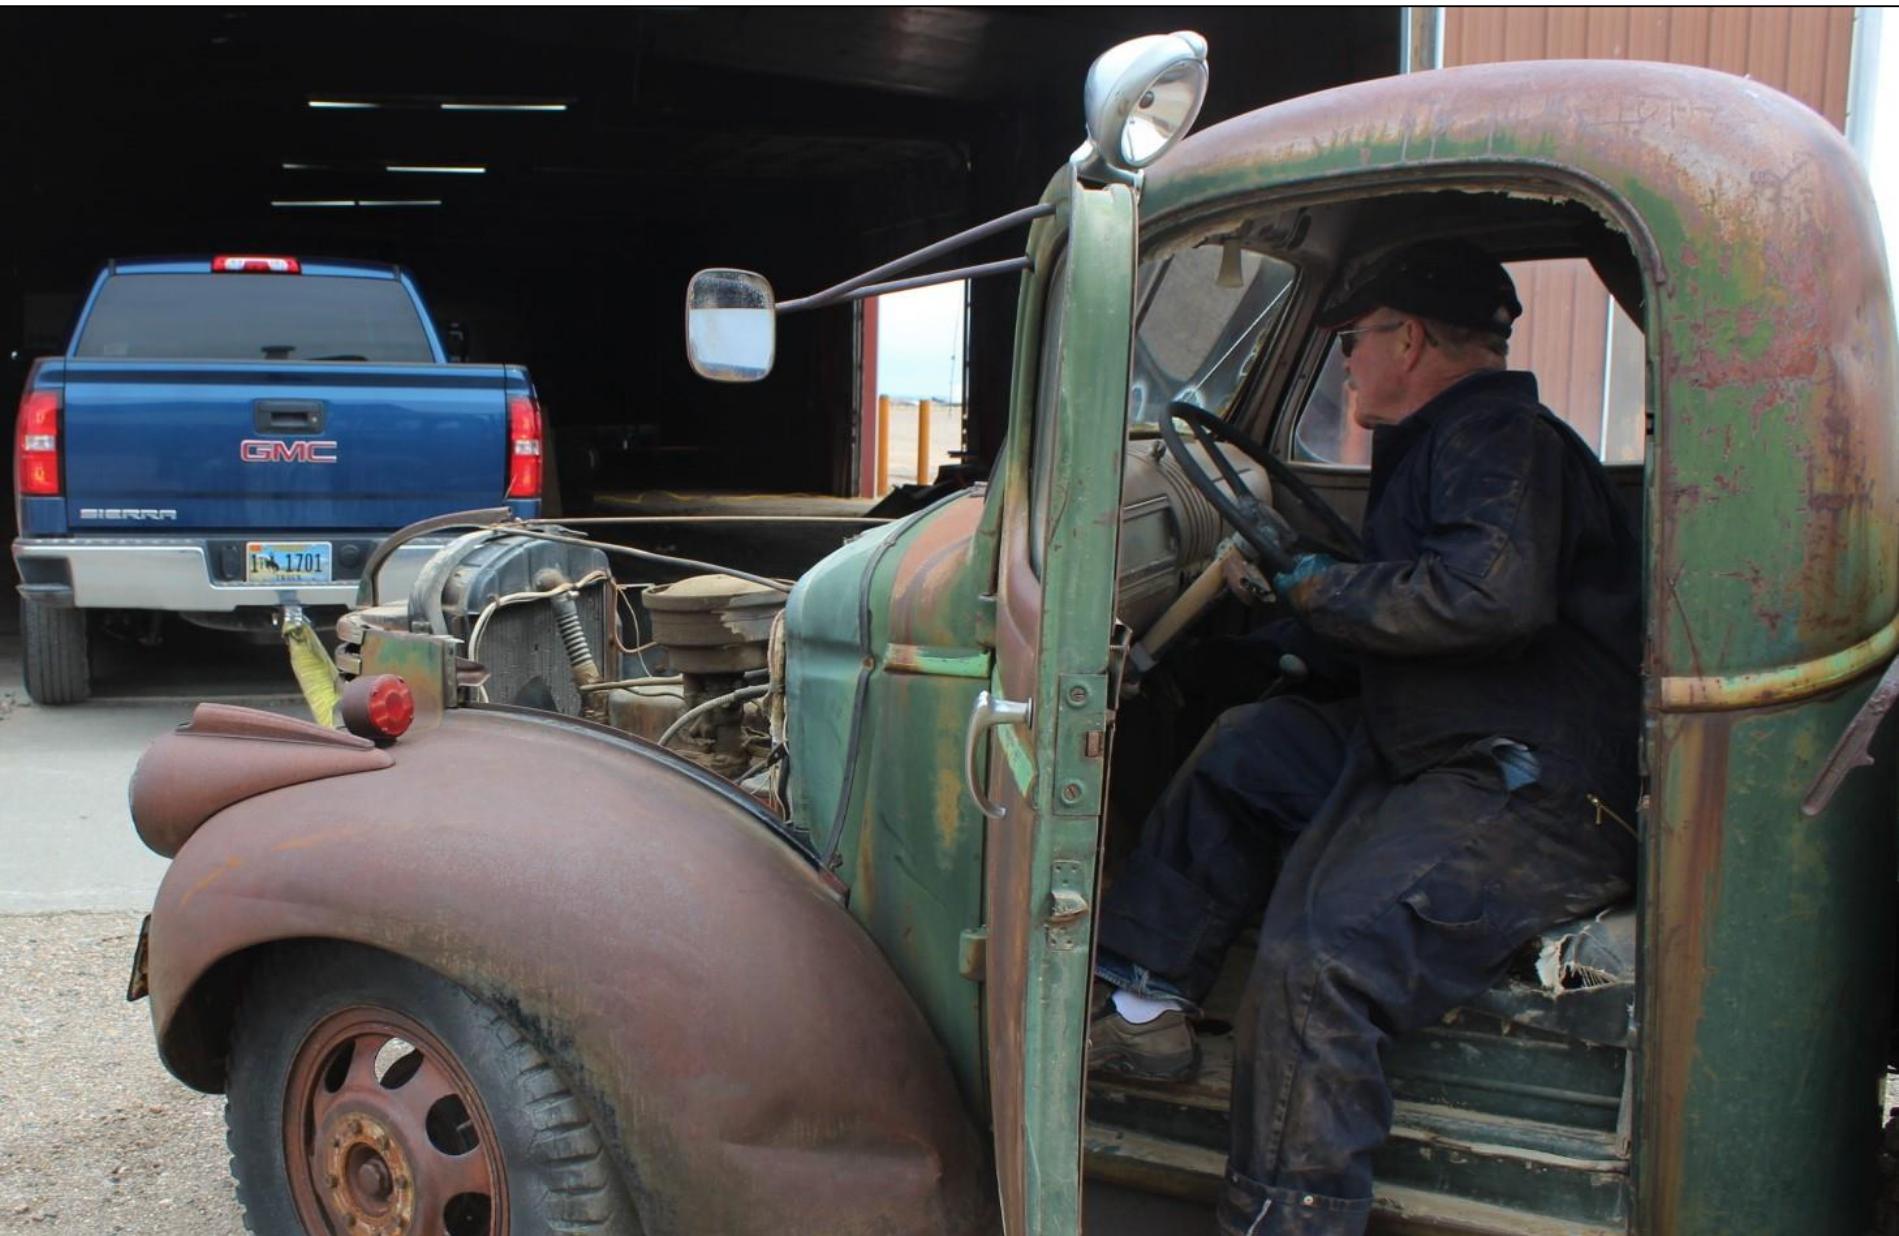
The 1941 truck is mostly complete and original, and will provide needed parts for the fire truck. It will also serve as a guide for restoration, since the fire truck has many modifications from factory original.

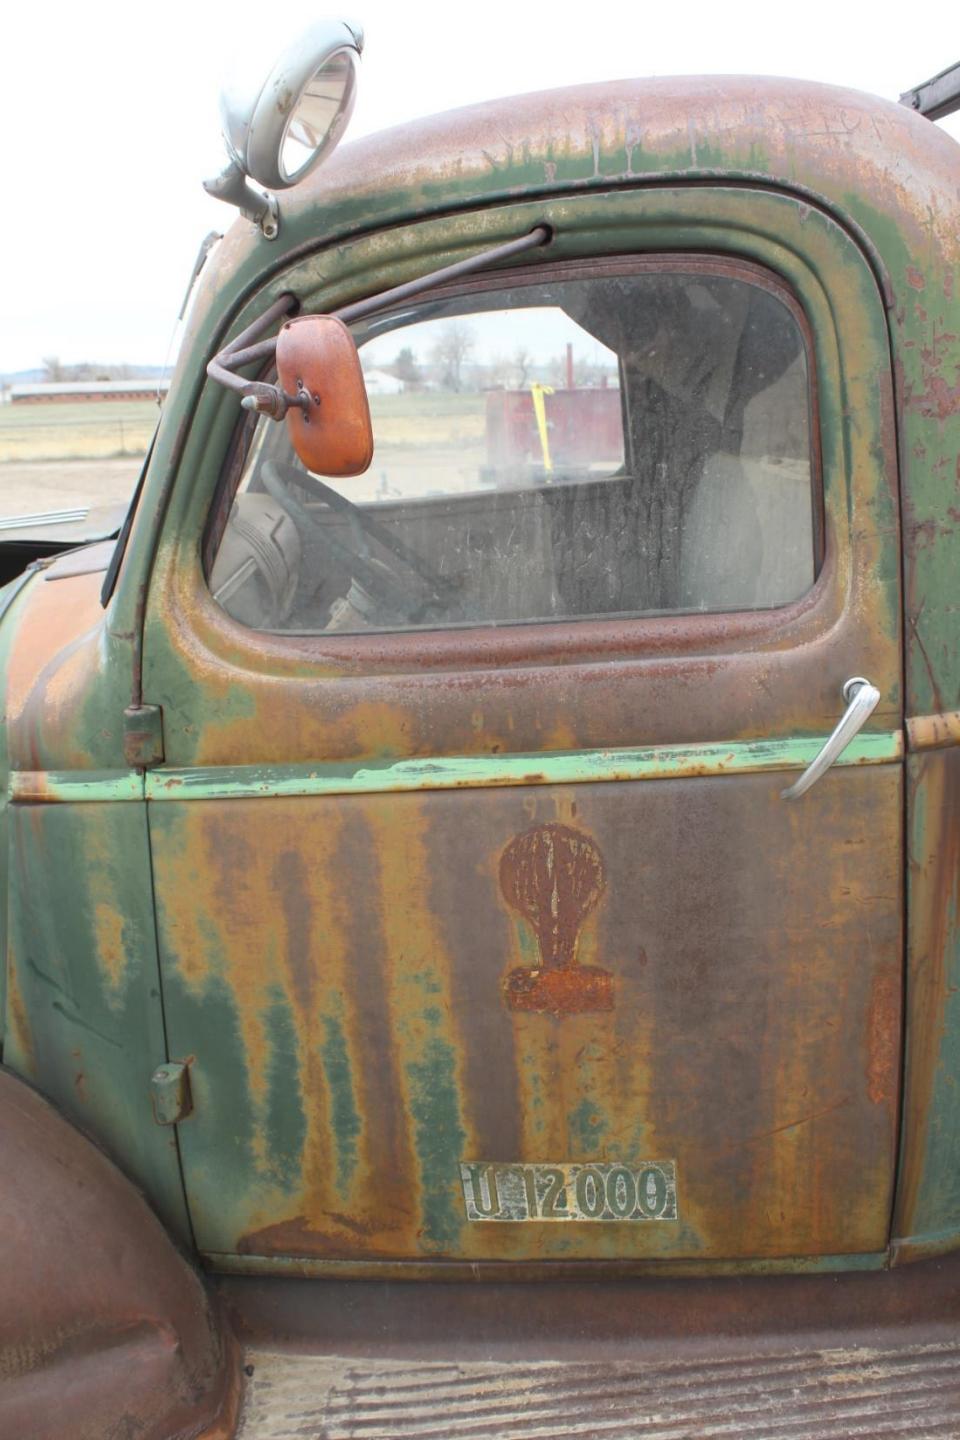
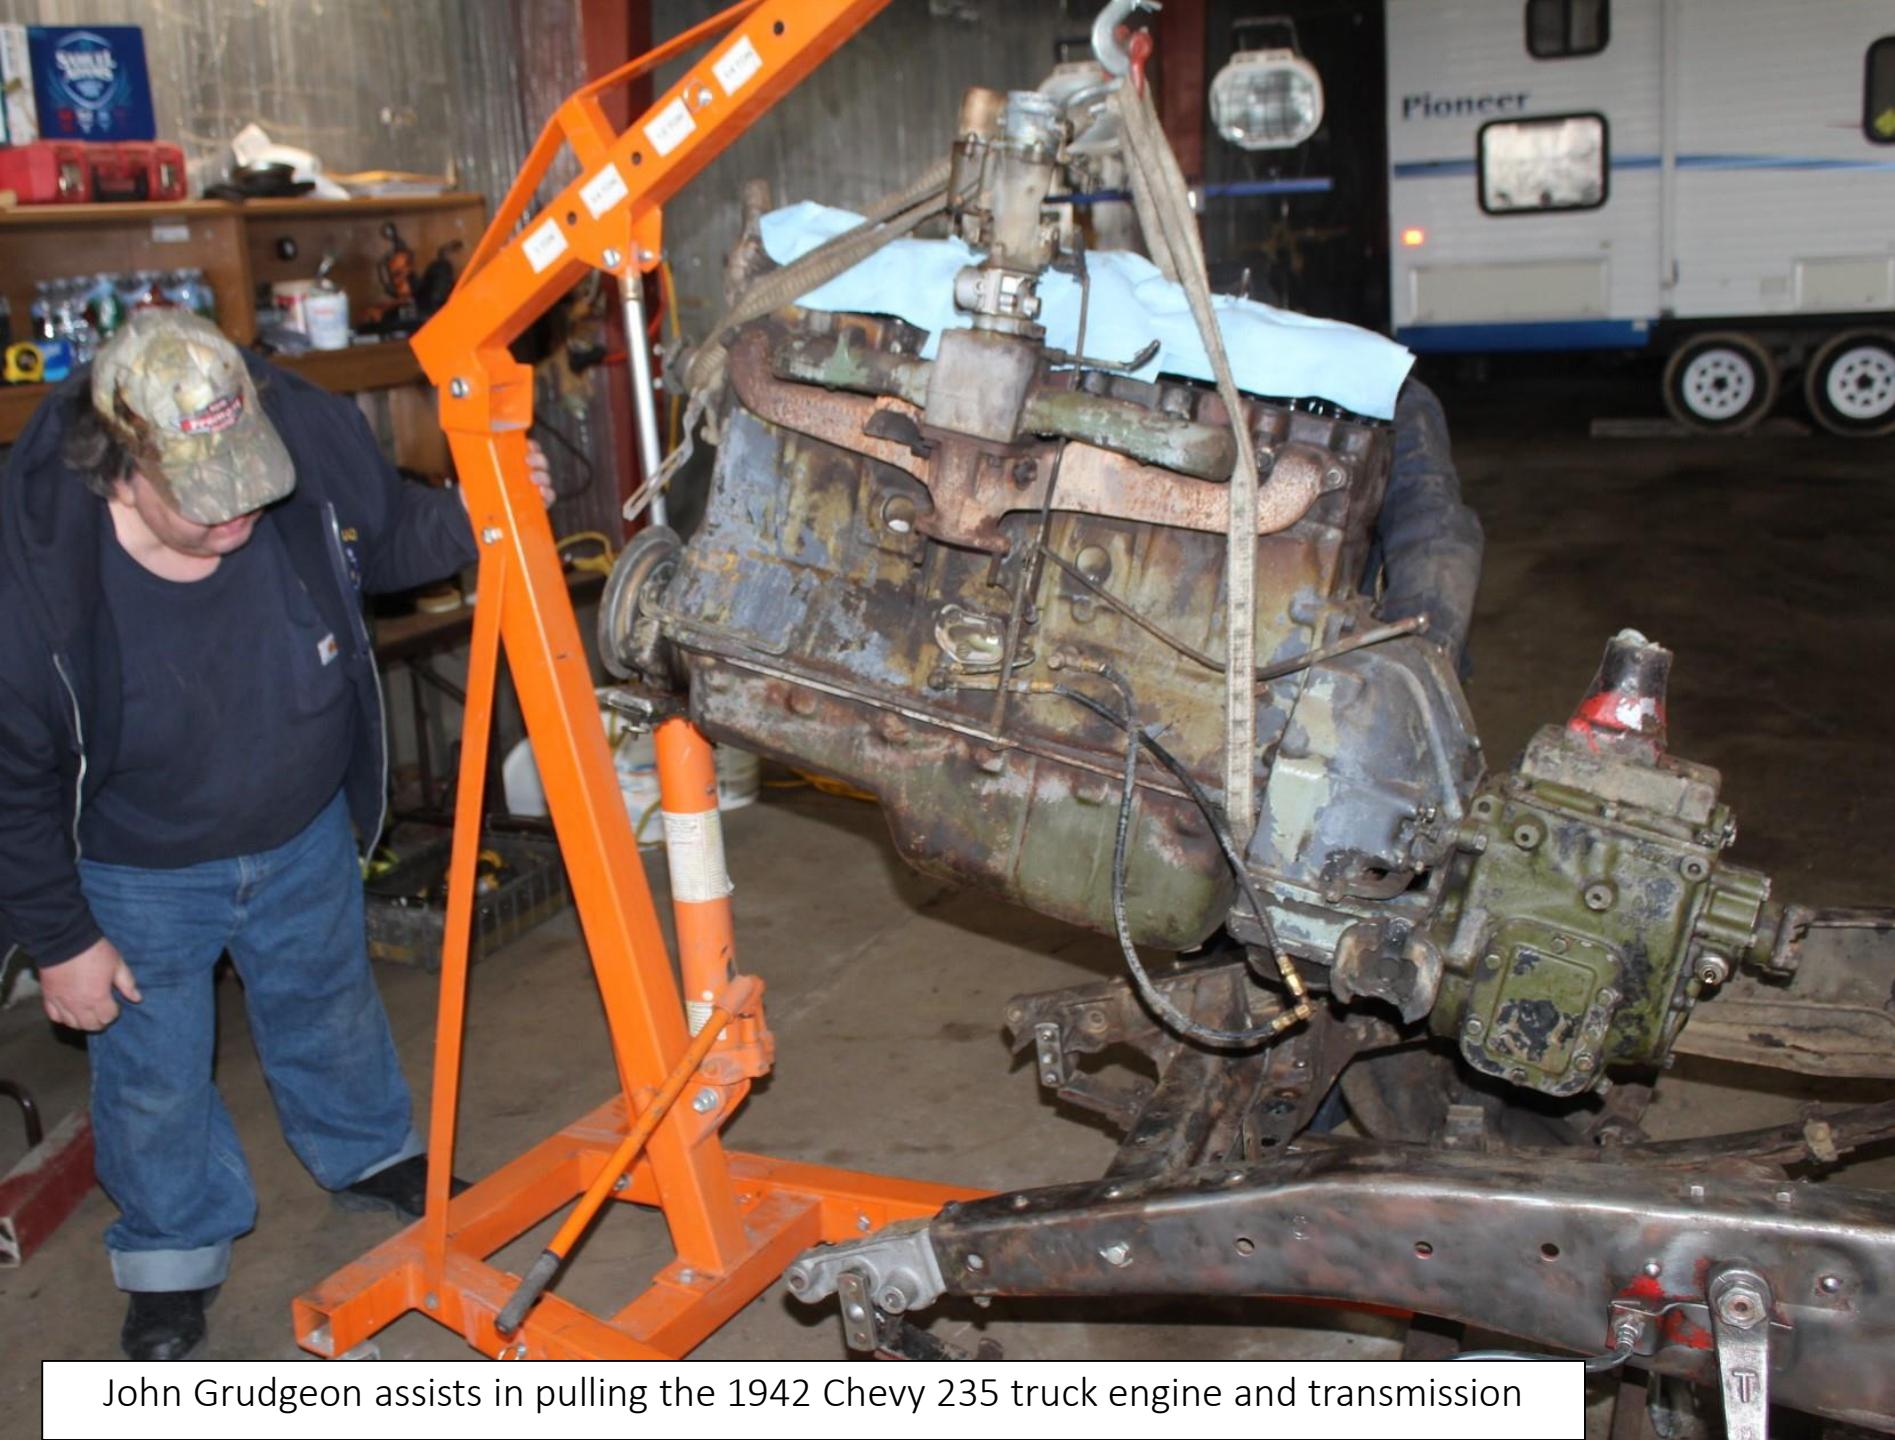
John Grudgeon assists in pulling the 1942 Chevy 235 truck engine and transmission

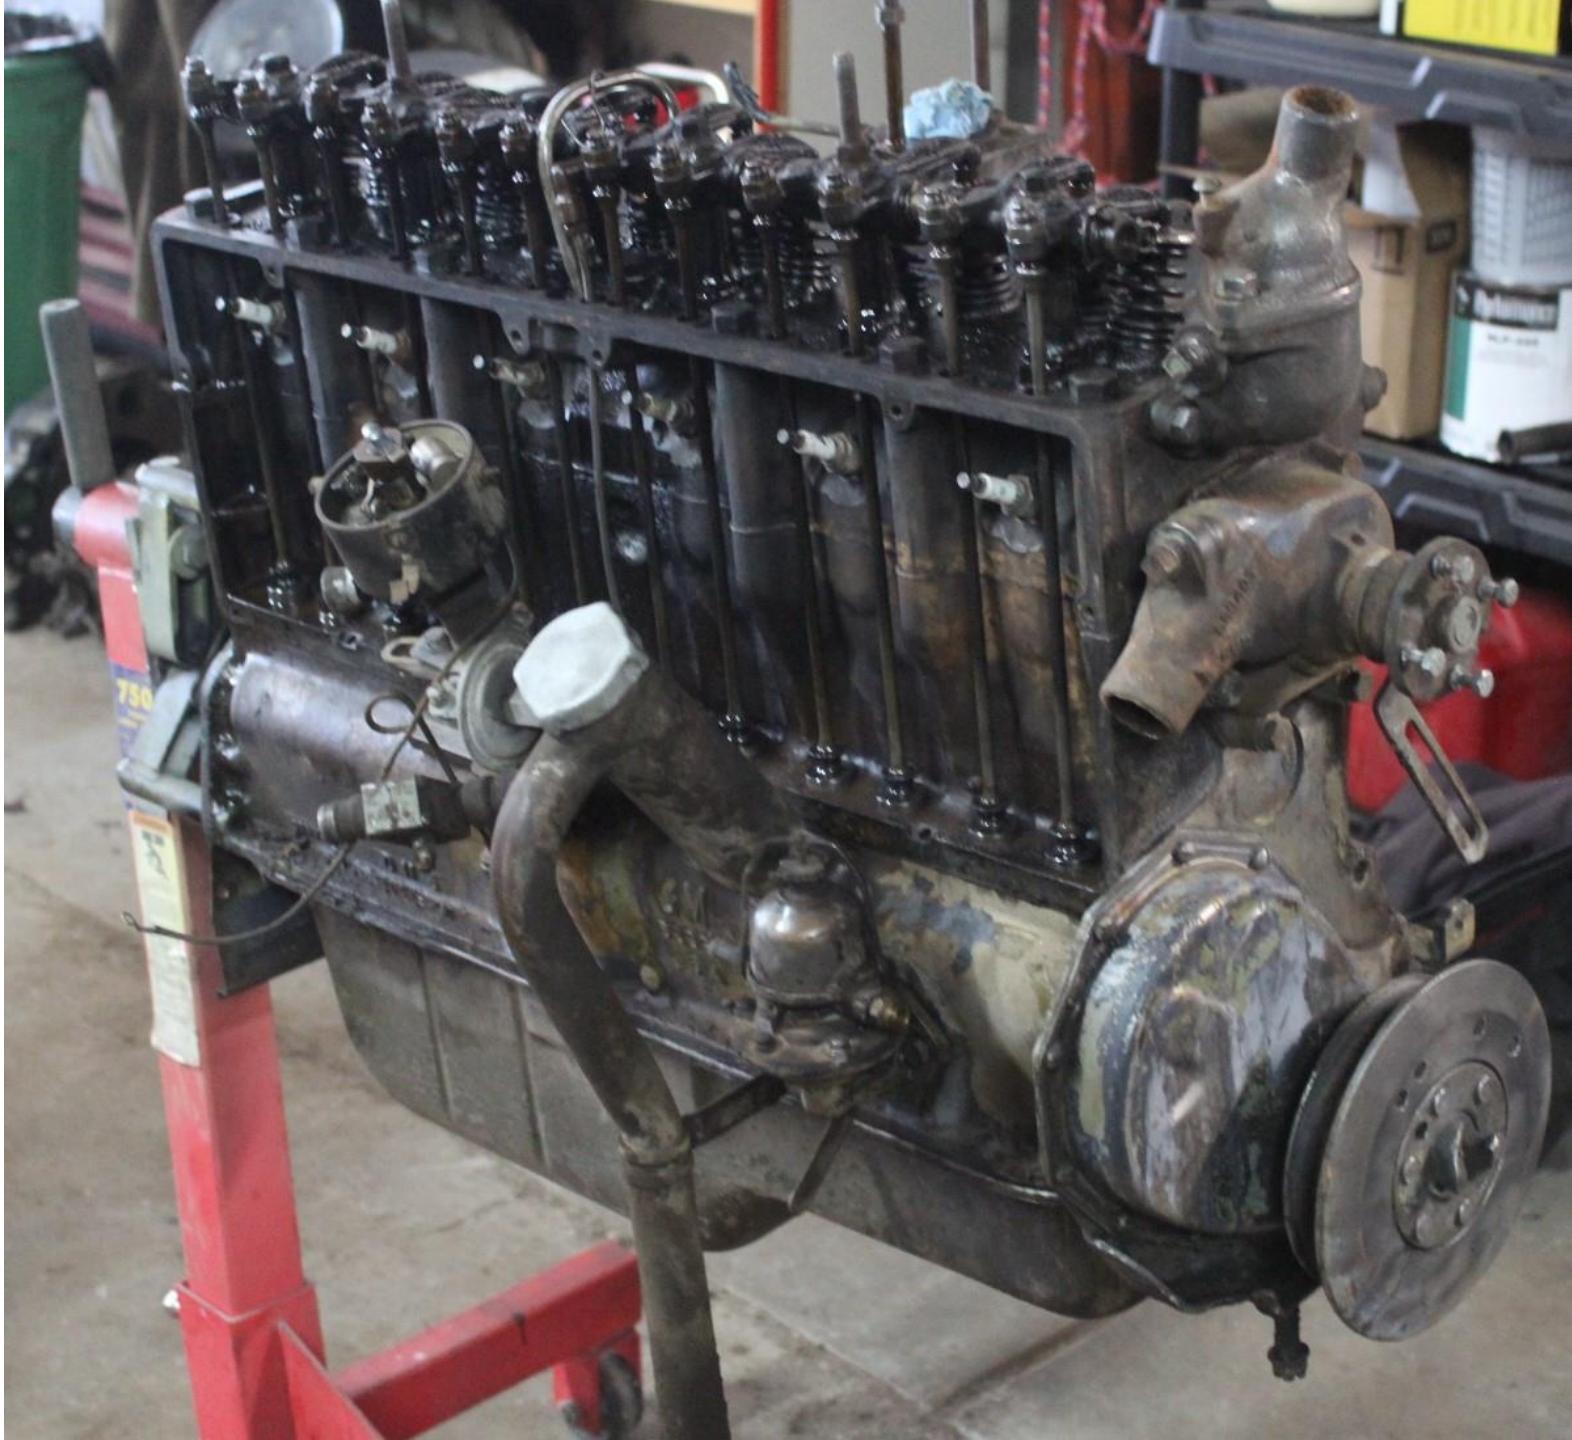
Mike Johnson and Mike Kennedy remove the bellhousing from the engine block. The clutch and flywheel had to be removed to get at the bellhousing bolts. The clutch components have had reasonably good care, and will not be replaced. The throwout bearing is an inexpensive maintenance item, and will be replaced.
