JOSIAH GIRLS SECONDARY SCHOOL THE JGSS ROTARACT CLUB

ROTARY CLUB BUKOBA

A CONCEPT NOTE FOR RAIN WATER HARVEST PROJECT 2020/2021

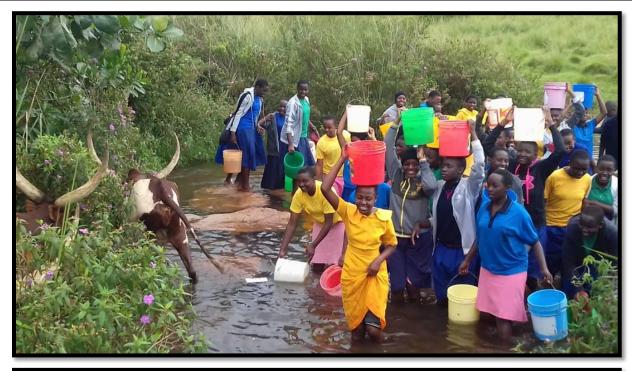
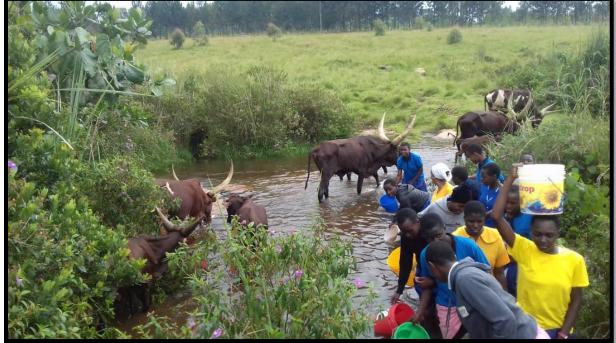
Caption 3&4: It is a shared source between the school and animals with high degree of contamination.

- Steep slopes, mountainous, long grasses and bushes hence insecurity to students.
- Water is contaminated since it is collected from a shared source being used for washing motorbikes and for cattle drink each afternoon.

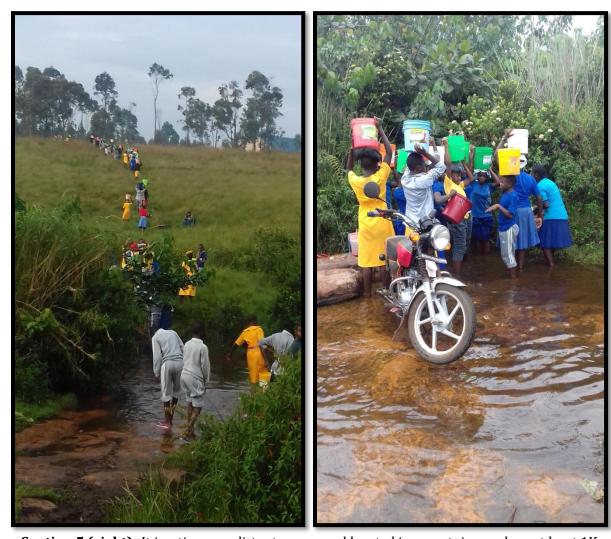
Caption 5 (right): It is a tiresome distant source and located in mountainous place at least 1Km walk from school to collect water.

Caption 6 (left): It is shared source where surrounding communities wash their motorbike and other farm equipment after shamba work.

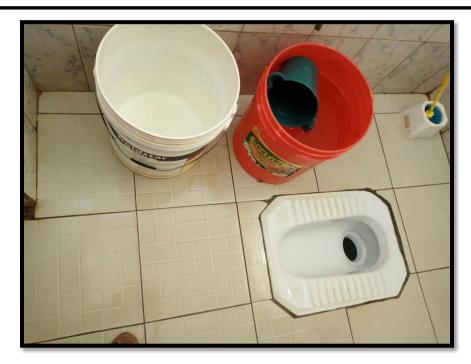
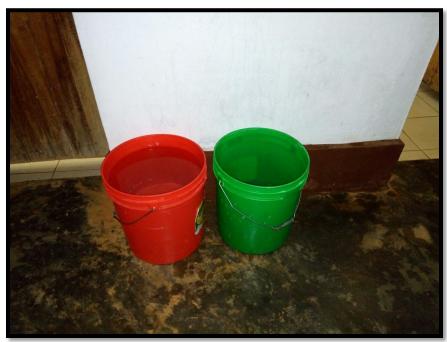
Caption 9&10: Poor sanitation and hygienic practices is due to water shortages in school. Flash toilets need pouring water by using water stored in buckets in wash rooms.
